**Adur District Council**

**Southlands  
Conservation Area  
Character Appraisal and Management  
Strategy**

**Approved 24 July 2008**

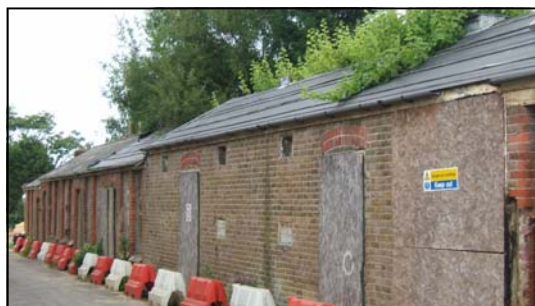
**Fig. 4 Accessory buildings on site**

The other accessory buildings on the site are all of a simple and functional design and small scale. Some are in an extremely poor state of repair and have been subject to significant vandalism and material removal. While these are of less overall importance, compared to the other larger buildings on site, they are a reminder of the history of the workhouse and have a role in providing separation between spaces within the workhouse and from the neighbouring development.

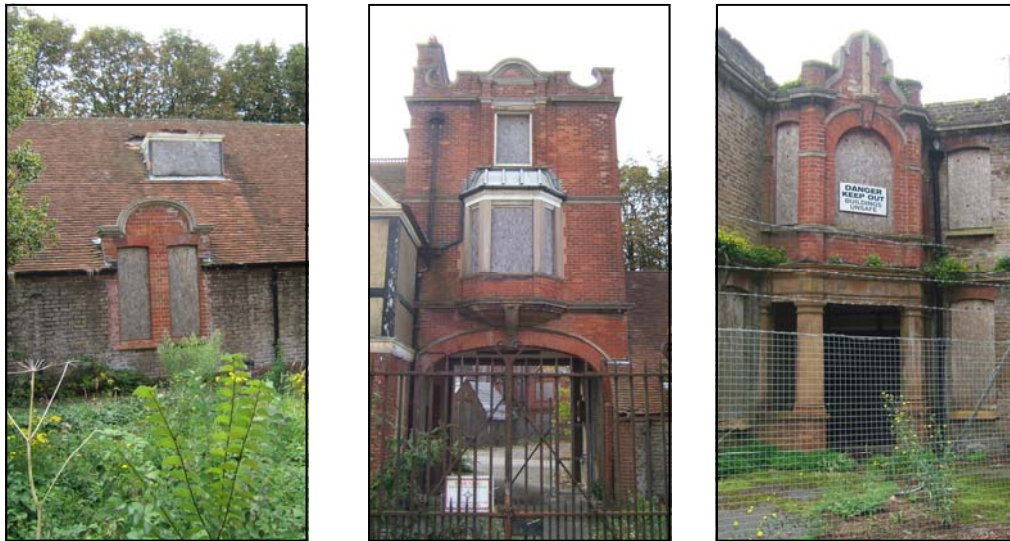
**Figs. 5, 6, 7: Architectural details (from left): Dutch gable on entrance block, entrance arch on entrance block, entrance to refectory block**

Architectural detailing is most prominent in the buildings visible to the public. The front elevation of the entrance block in particular is most decorative, containing an array of different design features and mixture of types of materials as detailed below. The decorative entrance to the refectory block carries on the theme of this entrance block in that the shape of the Dutch gable is reflected in the moulded render above the entranceway. Otherwise, simple architectural detailing is evident, such as rubbed brick lintels on all buildings, a

cantilevered chimney on the dormitory block, and decorative ridge tiles on the roofs of the main buildings.

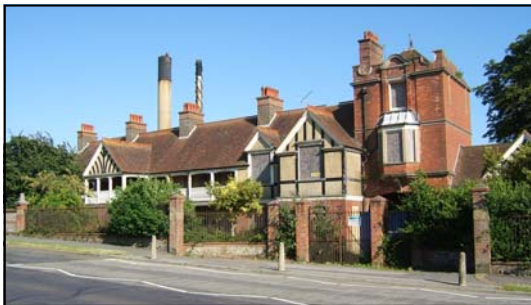
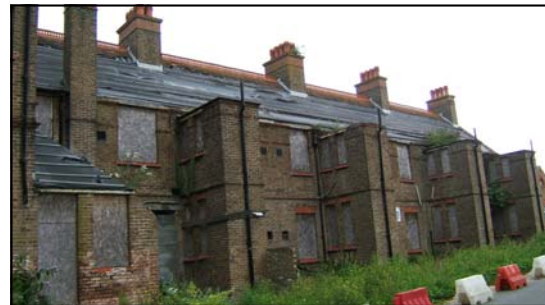
**Figs. 8 & 9: Entrance block front and rear**

The wing to the west is single storey with a hipped roof, containing a pitched roof dormer jutting above the ridgeline at its eastern most end and four small evenly spaced flat roofed dormers across the remainder of the roof space. At ground floor level, Dutch gable style windows are an attractive feature. The relatively uniform elevation is broken towards the western most end by a feature with a hipped roof which projects slightly above the ridgeline and forward on the main building line.

The rear elevation is plain, containing narrow, flat roofed, two storey toilet block extensions.

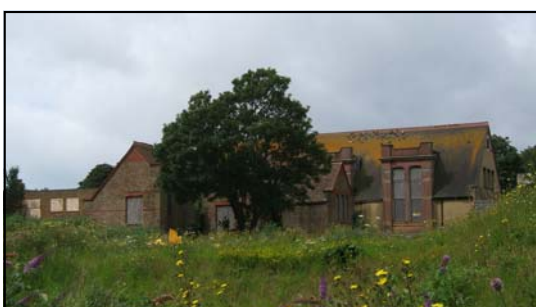
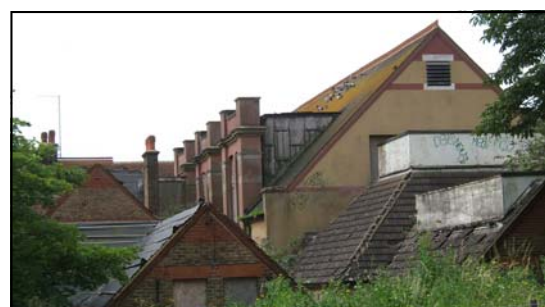
**Figs. 10 & 11: Refectory block dining hall**

This was the main civic building of the workhouse, located in the centre of the workhouse site between the two dormitory blocks and comprising three parts. This block is in significantly poorer condition than the other main buildings on site.

The main body of the building contained the dining hall. This element was built first and is one storey with a large pitched roof and large art-deco style flat roofed dormer windows.

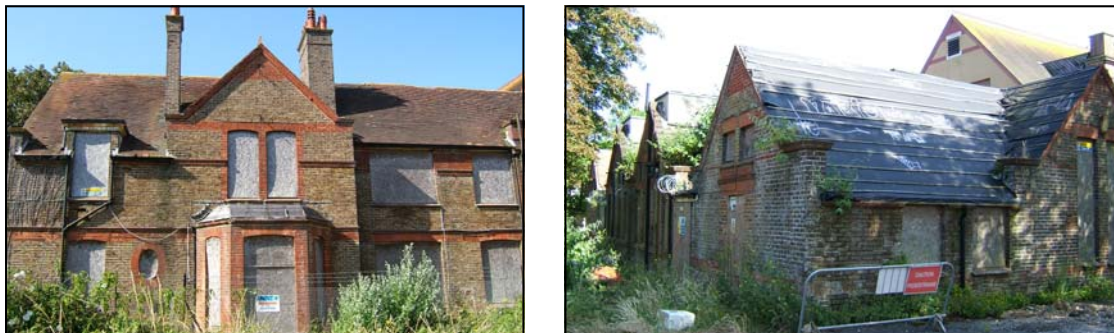
**Figs. 12 & 13: Secondary halls (south elevation) and kitchen block**

Two two-storey 'L' shaped secondary halls to the main entrance contained the Master's House, committee rooms and offices. The distinctive entrance is a 'corner' entrance located on the western side of the building with a ground floor

open pillared entrance bay and first floor bay window with decorative parapet wall above. This entrance and the elevation to the south are considered to be the most attractive elements of the building.

A single storey block at the front of the dining hall contained the kitchen facilities. The loss of this addition would not have a significant impact on the conservation area if it were to be replaced with new development that is sensitive to the rest of the block and the area as a whole.

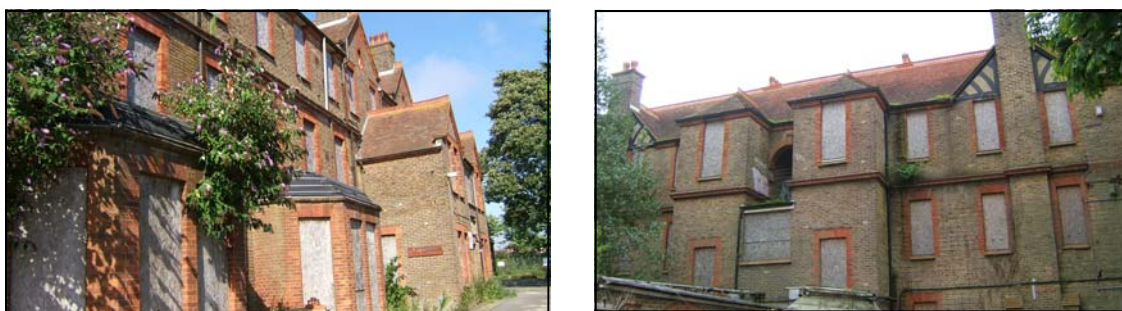
**Figs. 14 & 15: Men's dormitory block**

The symmetrical dormitory block is the only one remaining of the four original accommodation blocks on the site. This block is located near the southern boundary of the designated conservation area, well back from the road. Like the entrance block, the building is long and narrow (approximately 50 metres long and less than 10 metres deep) and three storeys high.

The main body of the building has end gables with cantilevered primary chimney stacks on the end elevations. The southern elevation contains a series of bay windows and a forward projecting two storey gabled extension in the centre. The northern elevation contains small hipped roof projections in the centre with gabled projections at each end. Part of the original walkway (which linked it to an identical block to the north) remains, along with two ventilated pavilions (most likely shower blocks) in poor condition.

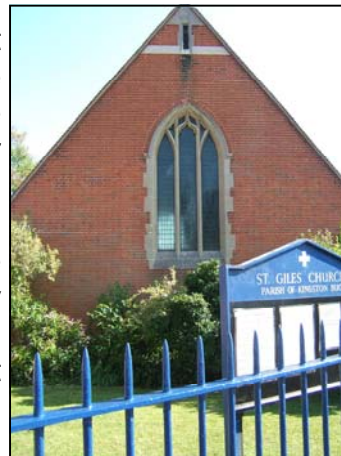
**Fig. 16: St Giles Church**

This red brick church was the workhouse chapel. Built in 1906, it became available for general public use during the 1930s and is located immediately to the west of the workhouse buildings fronting Upper Shoreham Road. The front elevation comprises a full gable and contains a plain perpendicular window with sandstone quoined dressings. The side slopes of the roof each contain small pitched roof dormers, set very close together towards the rear. A reserved stone bell tower projects from the rear wall. On the west elevation, a flat roofed side extension has been added.

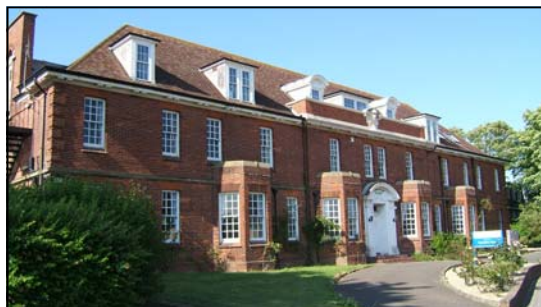
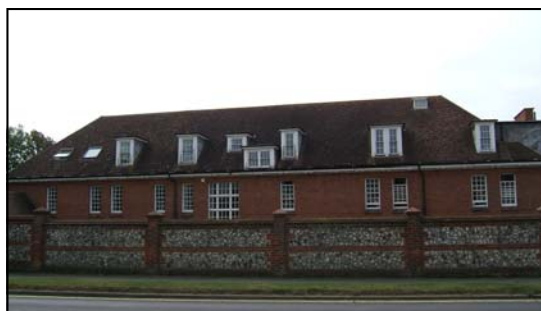
**Figs. 17 & 18: Thakeham House**

This building is located outside of the current boundary of the conservation area but at the head of a group of attractive buildings on the western edge of the functioning hospital. It is a 1950s Edwardian style building in the manner of a country house of high quality red facing brick. The southern elevation is the more attractive side, including a central decorative entrance, four ground floor bay windows and regular fenestration. The hipped roof space contains strong featured dormer windows on both sides and the main body of the building contains traditional multi-pane sliding sash windows with rubbed brick lintels. At the western end an interesting feature is a capped chimney which has been converted into an entrance way to the extended roof space. While not an original part of the workhouse complex, it has landmark quality and is representative of the gradual development of the hospital adjacent to the workhouse.

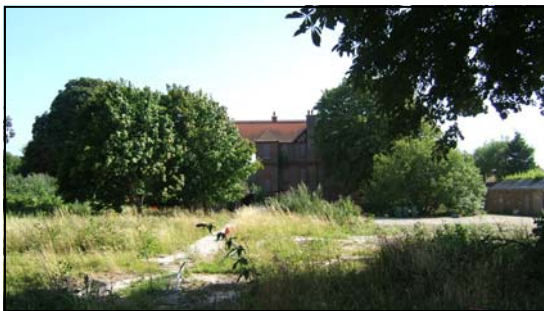
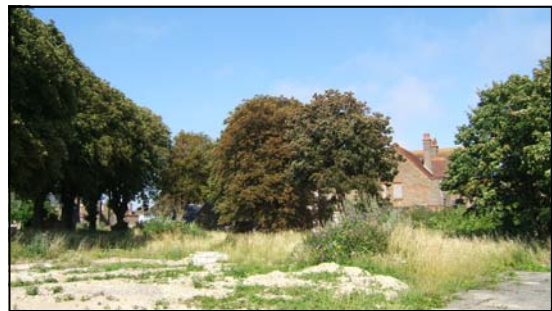
Figs. 19 & 20: Trees and open space

In the interior of the site, the protected trees include a group of large mature trees around the open space between the dormitory block and the refectory block. The majority of these are horse chestnuts, with a small group of hollies in front of the dormitory block. A single sycamore tree is also located on the south side of the dormitory block.

The trees are attractive features of the interior of the site and should be protected and incorporated into development proposals for the site. If exceptionally a TPO tree needs to be replaced this would need to be with an appropriate specimen. The group of horse chestnuts in the centre of the conservation area could form important landscape features as part of an enhanced area of open space.

- Incorporate existing trees within the re-developed site. In exceptional circumstances where this is not practical, the trees shall be replaced with appropriate specimens.
- Council require the provision of a public open space (a minimum of 2300m<sup>2</sup> in size) in the centre of the conservation area, as part of any redevelopment scheme.
- Retain and incorporate the group of horse chestnuts as part of an enhanced area of open space in the centre of the conservation area.
- Undertake tidying of the existing grounds and keep regularly maintained.
- Council require an appropriate landscaping plan (including additional trees if necessary) to be submitted in relation to any redevelopment scheme for the site.
- Undertake paving of road carriageways using traditional materials appropriate to the period of the conservation area buildings.

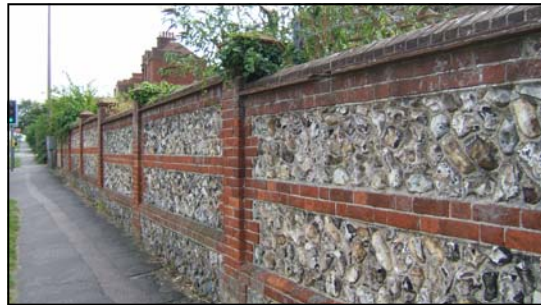
Fig. 21: Front boundary wall

The former workhouse buildings are separated from the road by an attractive wall constructed of red brick and with flint accent. Red brick pillars separate the sections of wall and around the former main entrance way there are iron railings and iron gates. The wall is approximately 2.5 metres high along the Upper Shoreham Road frontage and provides good security but also visually isolates the space from the surrounding area. It is continuous except for a 30 metre section to the north-east of the entrance block where the rear wall of an accessory building acts to enclose the site and another section further to the north-east where part of the wall has been removed to create the temporary access. Along the wall, it is evident that small gaps (eg pedestrian accesses) have also been filled in. One gap has been filled with concrete blocks which is a poor choice of material and is inconsistent with the character of the remainder of the wall.

This wall is a key feature of the conservation area and street scene and it is important it is retained. The Development Brief suggested an opportunity to create a more open frontage by replacing the top panel of sections of the wall with iron railings, which would assist in providing natural surveillance to the footpath and integrating the development within the surrounding community.

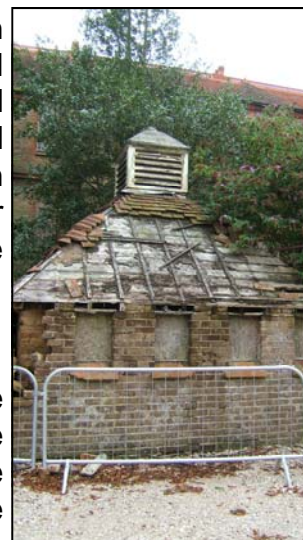
Fig. 24: Run down buildings

The existing buildings on the site have been empty in recent years following the withdrawal of hospital services. As such, their condition has deteriorated and they have become subject to significant vandalism and theft of materials. Account will be taken of the condition of the building as part of the wider aim to preserve or enhance the character and appearance of the conservation area.

- Council support redevelopment proposals for the site which aim to retain, refurbish and reuse the existing buildings in a way that compliments the character of the original buildings. Account will be taken of the condition of the buildings in assessing proposals and their economic viability. The developer will be required to submit sound economic information as part of the assessment.
- Prepare a Conservation and Management Plan to direct future care of the remaining buildings.

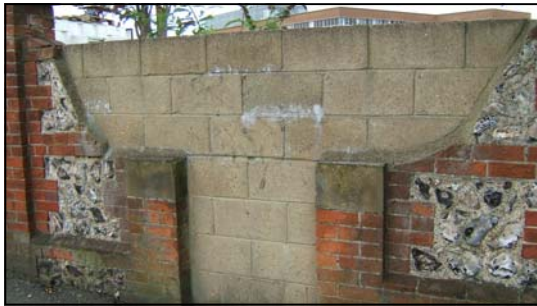
Fig. 26: Inappropriate filling of access point

The front wall is generally in a sound condition and attractive. However, the use of concrete blocks to fill in one of the past accessways does not contribute positively to its appearance. In addition, the condition of the wall fronting St Giles Church is deteriorating and has recently incurred some damage.

- Retain the existing boundary walls and gates.
- Create a new matching section to continue the wall if the accessory building on the road frontage is to be removed.
- Repair the damaged and deteriorating parts of the wall with materials matching those of the remaining parts of the wall.
- Remove the concrete blocks filling the previous access point and incorporate this space as a pedestrian access onto the site into any redevelopment scheme.
